Manhole Inspection Summary

Manhole # S2100_026MH

Insp Date: **7/9/07 10:58 AM**

Location Address: **WOODBROOK-PARKWOOD**

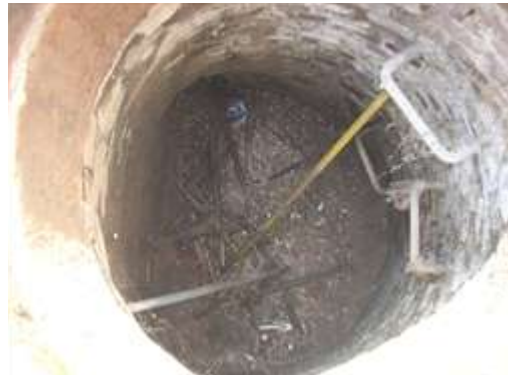
Top View

DEBRIS ON CHANNEL

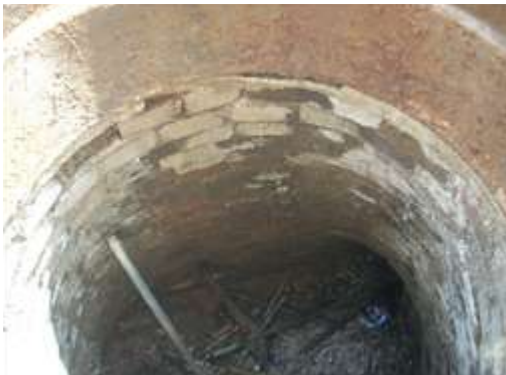
Defect 1

Infiltration: ☐ None ☐ Joint ☐ Cracks ☐ Mortar ☐ Roots ☒ Wall

INFILTRATION OF CORBEL

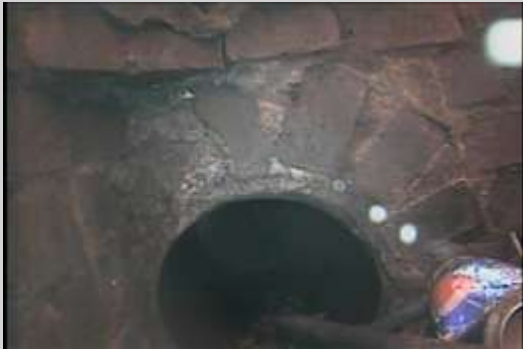
12 O'Clock Outflow

8 in. Circular Gravity Sewer
Pipe Out @ 12 O'Clock

Deposits: ☐ None ☐ Mud ☐ Sludge ☒ **Debris** ☐ Grease

Silt Depth: **2** (in.) Deposits Extent: **Light**
